RESIDENTIAL PROPERTY INSPECTION

1234 Main Street
La Grange Park, IL 60526

Buyer Name
03/03/2024 9:00AM

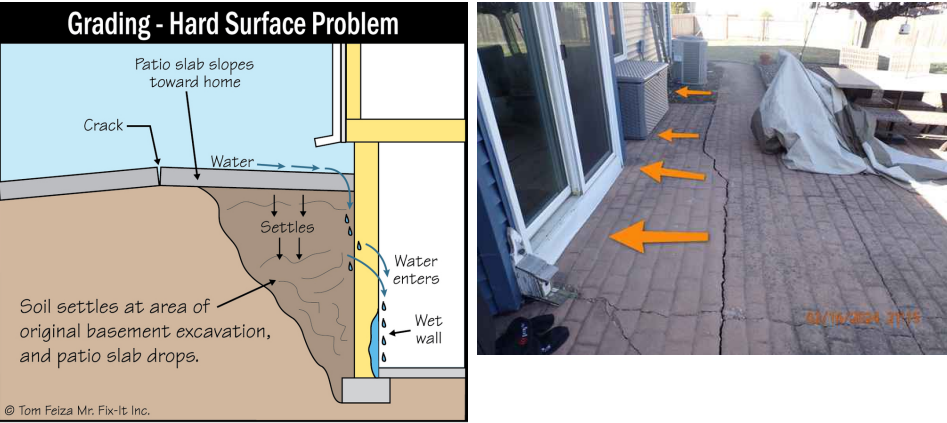
3.3.2 Grading/Lot Drainage

As mentioned in the "Grading / Drainage Information" comment above, hardscapes are recommended to slope away from the structure at 1/4" p/foot (2% grade). When the proper slope can not be achieved, drains should be installed as needed to manage rainwater runoff. An evaluation of the hardscapes around the property with repairs made as needed to allow for the proper runoff of rainwater is recommended to be conducted by a grading contractor, foundation contractor, or other qualified contractors.

Recommendation
Contact a qualified concrete contractor.

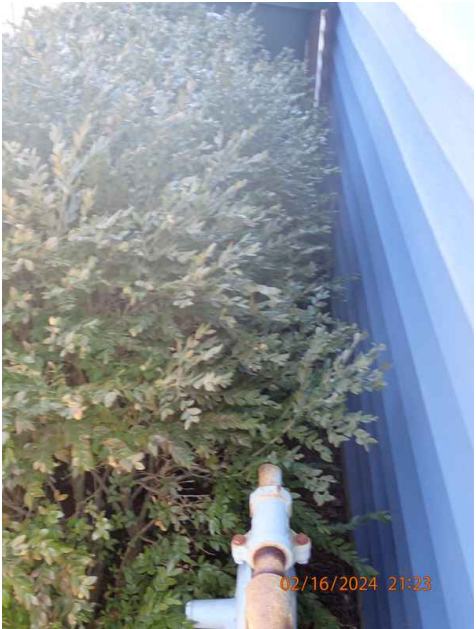
3.4.1 Vegetation
Observations

There was vegetation in contact with, or in close proximity to the home in areas. Pruning or removal of any plants within 1-2 feet of the home is recommended to be conducted by a qualified person to eliminate pathways of wood-destroying insects and allow moisture to adequately dry behind these areas after rainfall events.

Recommendation
Contact a qualified landscaping contractor

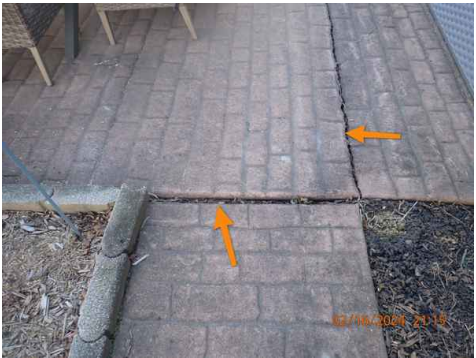
3.7.1 Patio

Cracking, heaving, settlement, movement, deterioration, and/or other deficiencies resulting in trip hazard(s) were present on the patio surface. Repairs are recommended to be conducted to these area(s) as needed for safety by a qualified contractor.

Recommendation
Contact a qualified concrete contractor.

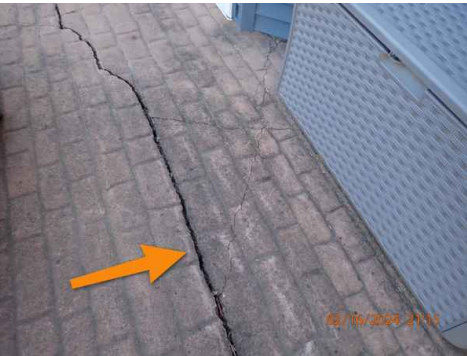
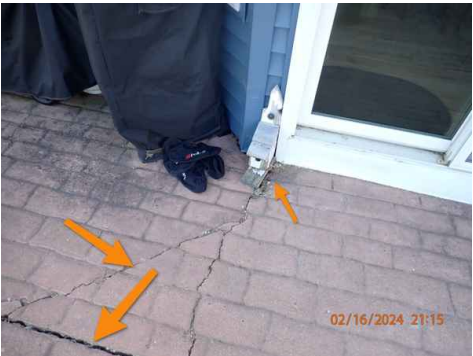
3.7.2 Patio

Damage was present to portion(s) of the concrete slab. Repairs are recommended to be performed as needed by a concrete contractor.

Recommendation
Contact a qualified concrete contractor.

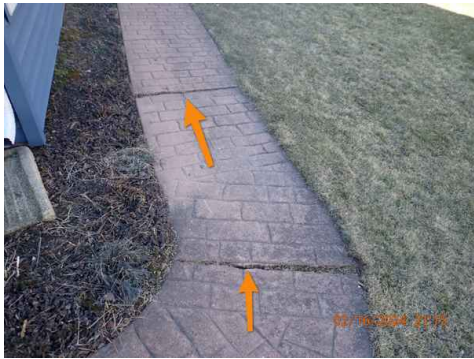
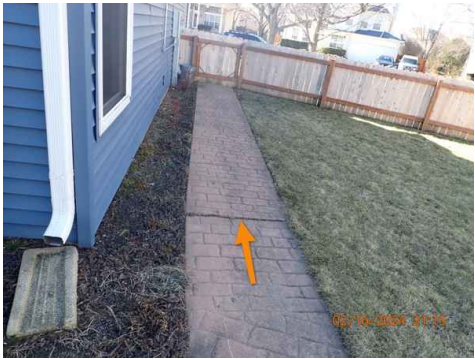
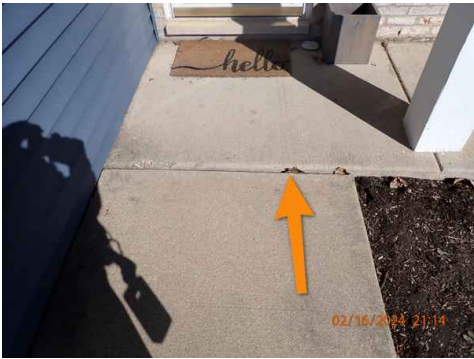
3.8.1 Concrete Surfaces

TRIP HAZARD(S) PRESENT

Contact a qualified concrete contractor.

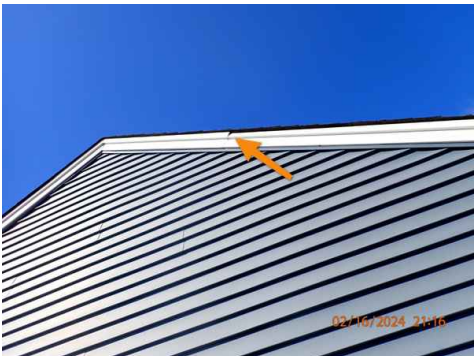
4.6.1 Eaves/Overhangs/Fascia

FASCIA WRAP - UNSECURED

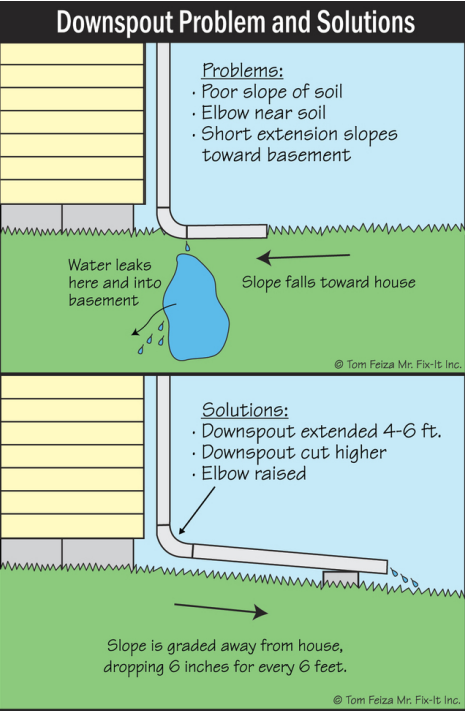
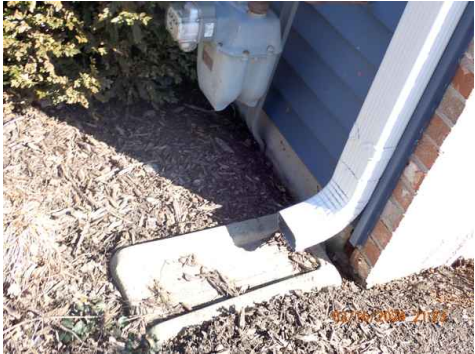
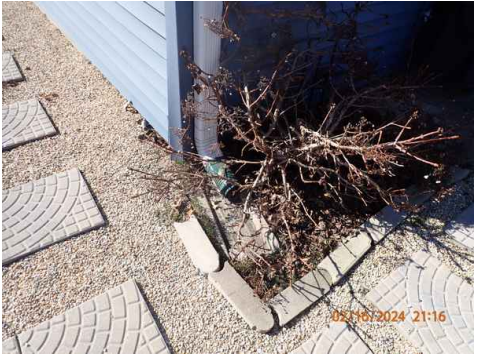
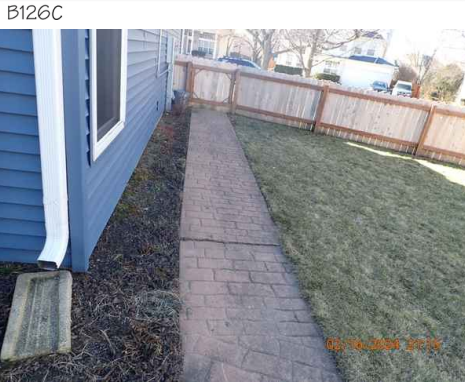
There were downspouts present that were discharging within five feet of the foundation of the home. Current standards require downspouts to be diverted at least five feet from the foundation of the home to prevent the grounds surrounding the foundation from becoming saturated. Saturated grounds can allow water / moisture to enter basement and crawl space areas, and in extreme cases can allow for settlement of the home. Properly extending all downspouts at least five feet away from the home is recommended to be conducted by a gutter contractor or other qualified person.

Recommendation
Contact a qualified gutter contractor

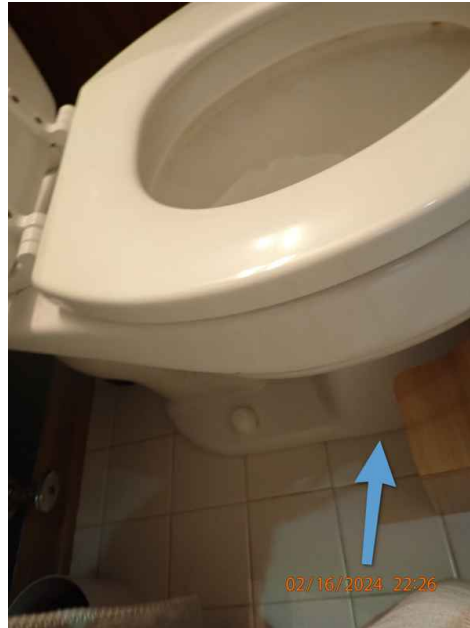
7.9.1 Toilet(s)

TOILET - BASE UNSEALED

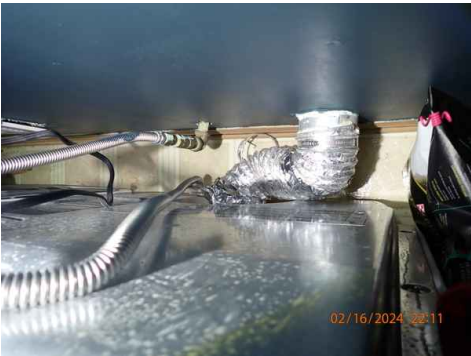
9.4.2 Dryer Vent

DUCT - FLEXIBLE MATERIAL
