RESIDENTIAL PROPERTY INSPECTION

1234 Main Street
La Grange Park, IL 60526

Buyer Name
03/03/2024 9:00AM

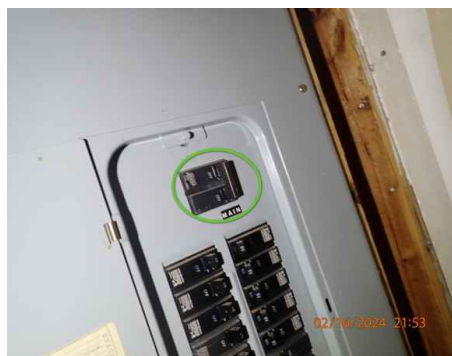
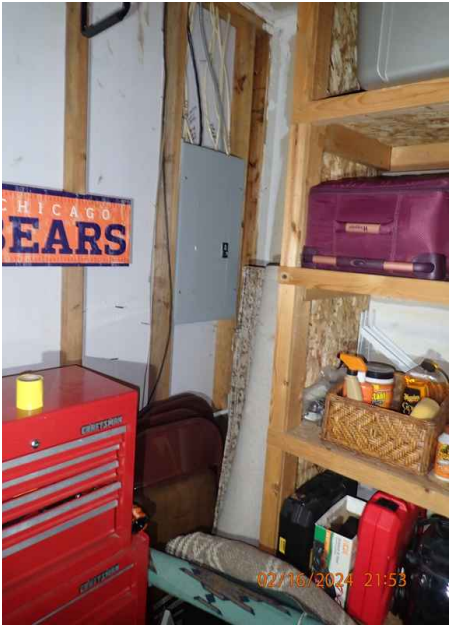
Main Breaker / Service Disconnect Location

At Main Breaker in the Electrical Panel

The pictured electrical service disconnect will shut off all power to the home in the case of an emergency, or for servicing.

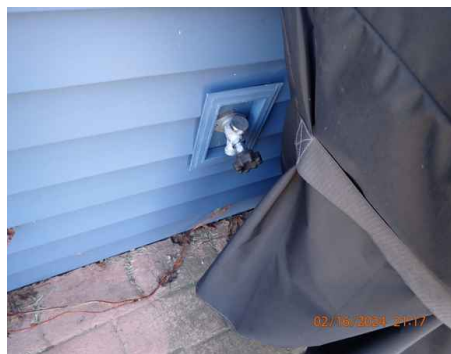
EXCL - The spigot(s) were not tested due to temperatures at the time of inspection below freezing. Water can freeze in the spigot or supply line creating damage after operation in freezing temperature. The spigots are excluded from this inspection. I recommend testing these spigots for proper operation prior to closing.

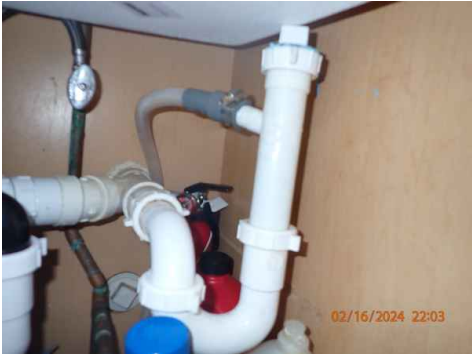
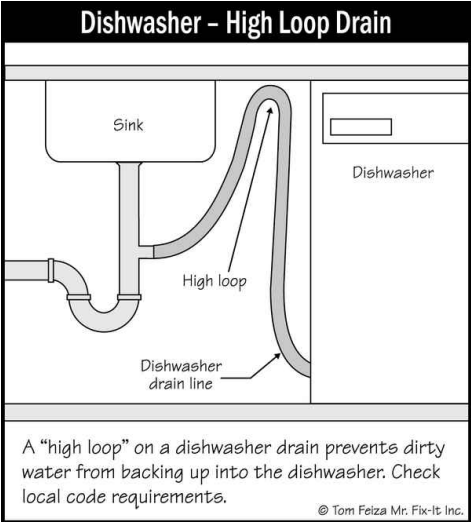
6.4.1 Undersink Plumbing - Kitchen

- ⚠️ 5.7.1 Roof - Gutters/Downspouts: Downspout(s) - Terminating Near Foundation
- ⚠️ 6.4.1 Kitchen - Undersink Plumbing - Kitchen: Dishwasher Drain - High Loop Missing

Contact a qualified plumbing contractor.

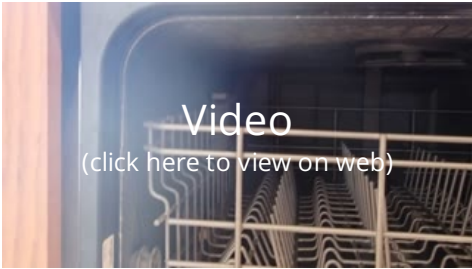
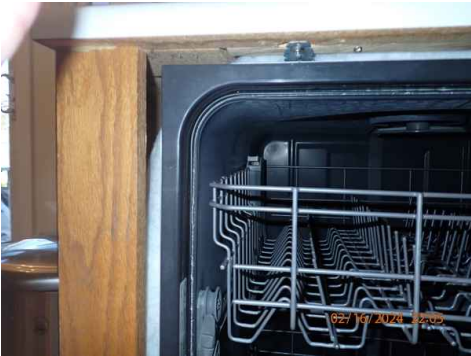
6.6.1 Dishwasher

- ⚠️ 6.6.1 Kitchen - Dishwasher : Dishwasher - Mounting Deficiency
- ⚠️ 6.7.1 Kitchen - Oven/Range: Safety - Anti-Tip Bracket Missing
- 🔧 7.4.1 Bathroom(s) - Sink(s): Faucet/Valves - Loose

Contact a qualified appliance repair professional.

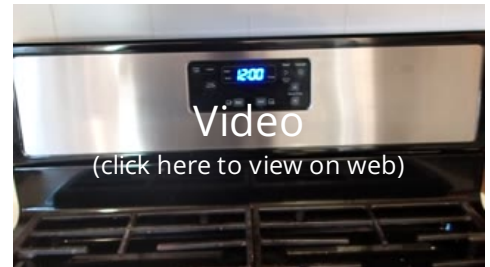
6.7.1 Oven/Range

Oven/Range: Range Anti-tip Bracket Presence
No

Contact a qualified appliance repair professional.

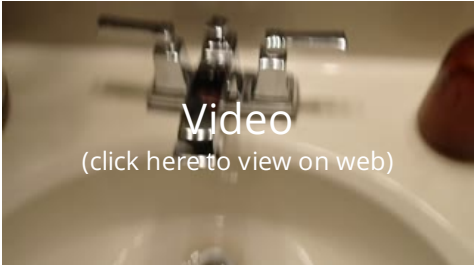
The faucet assembly was loose at the base. Proper securement of the assembly is recommended to be performed by a qualified person, typically this is associated with loose plastic nuts under the sink.

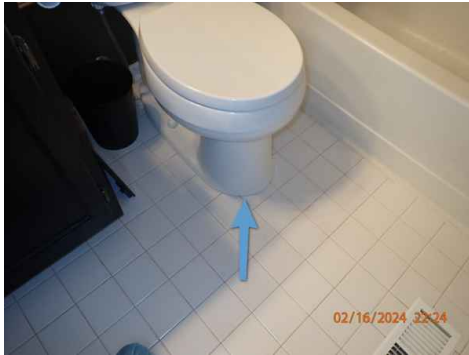
7.9.1 Toilet(s)

TOILET - BASE UNSEALED

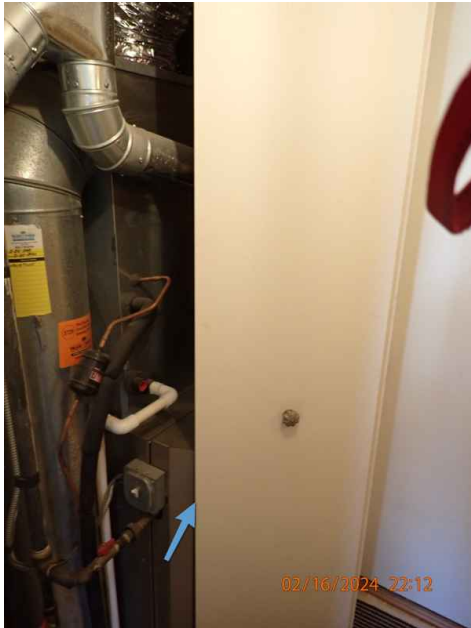
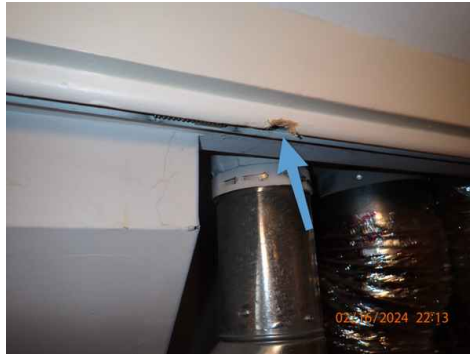
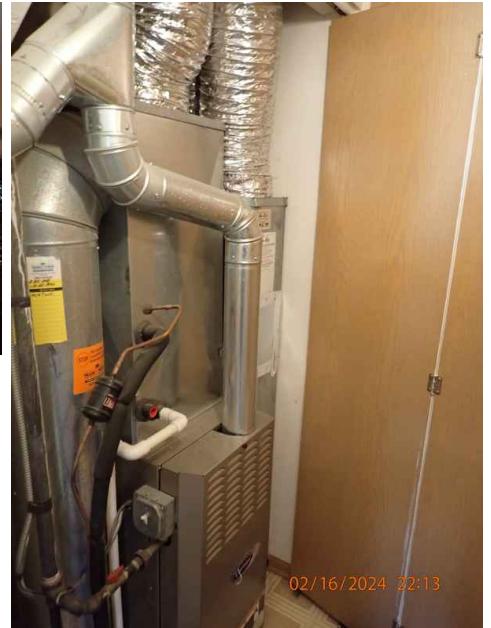
The bifold door makes contact with furnace. Recommend further evaluation by a door repair contractor. A notch was cut into the trim to release the wheel in order to service the furnace.

Contact a qualified door repair/installation contractor.

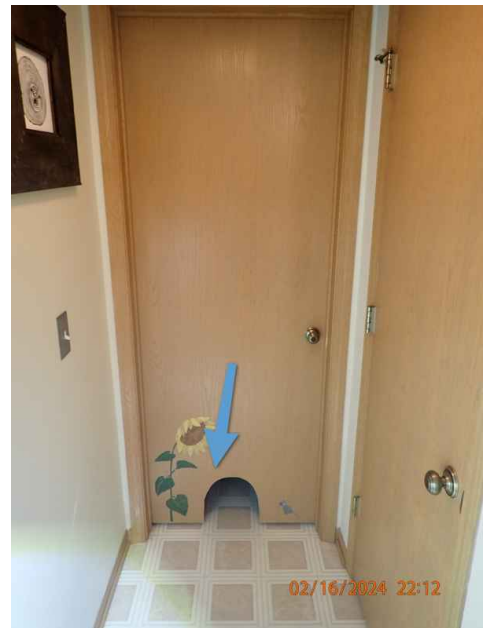
8.5.1 Interior Doors

GENERAL - DAMAGED

The referenced door(s) contained some degree of damage. Repairs or replacement of the doors as needed is recommended to be conducted by a qualified person. A cat access was cut into bottom of the door. Replacement is needed.

Contact a qualified handyman.

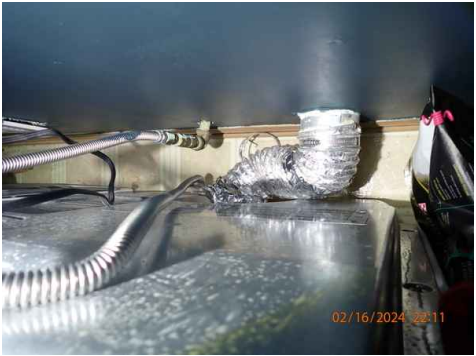
DUCT - IMPROPER MATERIAL

The dryer vent duct, or portions of it, consisted of an unrated or unlisted material. Replacement of the duct using proper materials is recommended to be performed by a qualified contractor.

Contact a handyman or DIY project

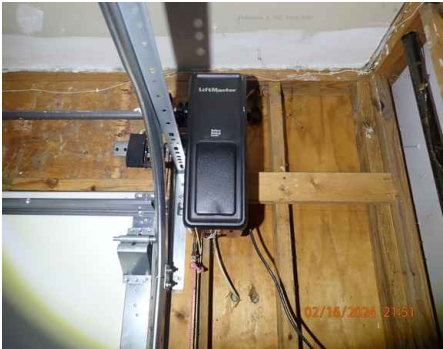
Garage Door Opener(s): Control(s) Proper Height

Yes

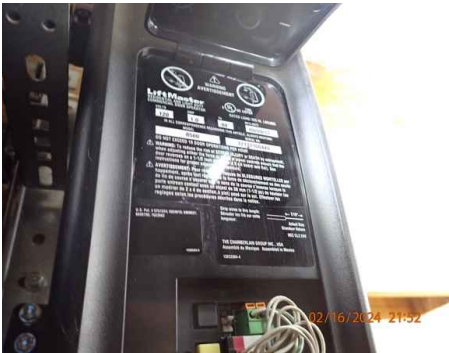
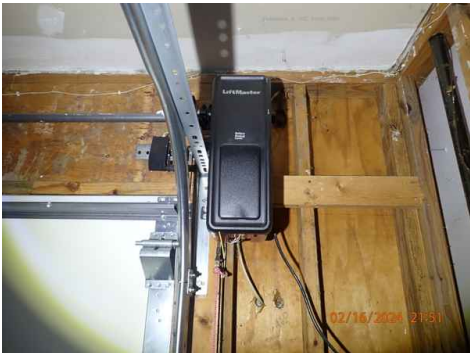
Garage Door Opener(s): Garage Door Opener Information

The garage door opener(s) were inspected by depressing the wall mounted transmitter and observing the openers functionality (remote transmitters are not tested). No reportable conditions were present at the time of inspection unless otherwise noted in this report.
